Lake Barton Dredging, Restoration and Riser Modification Project

A Fairfax County, VA, publication
July 16, 2019

Lake Barton (9992WP)

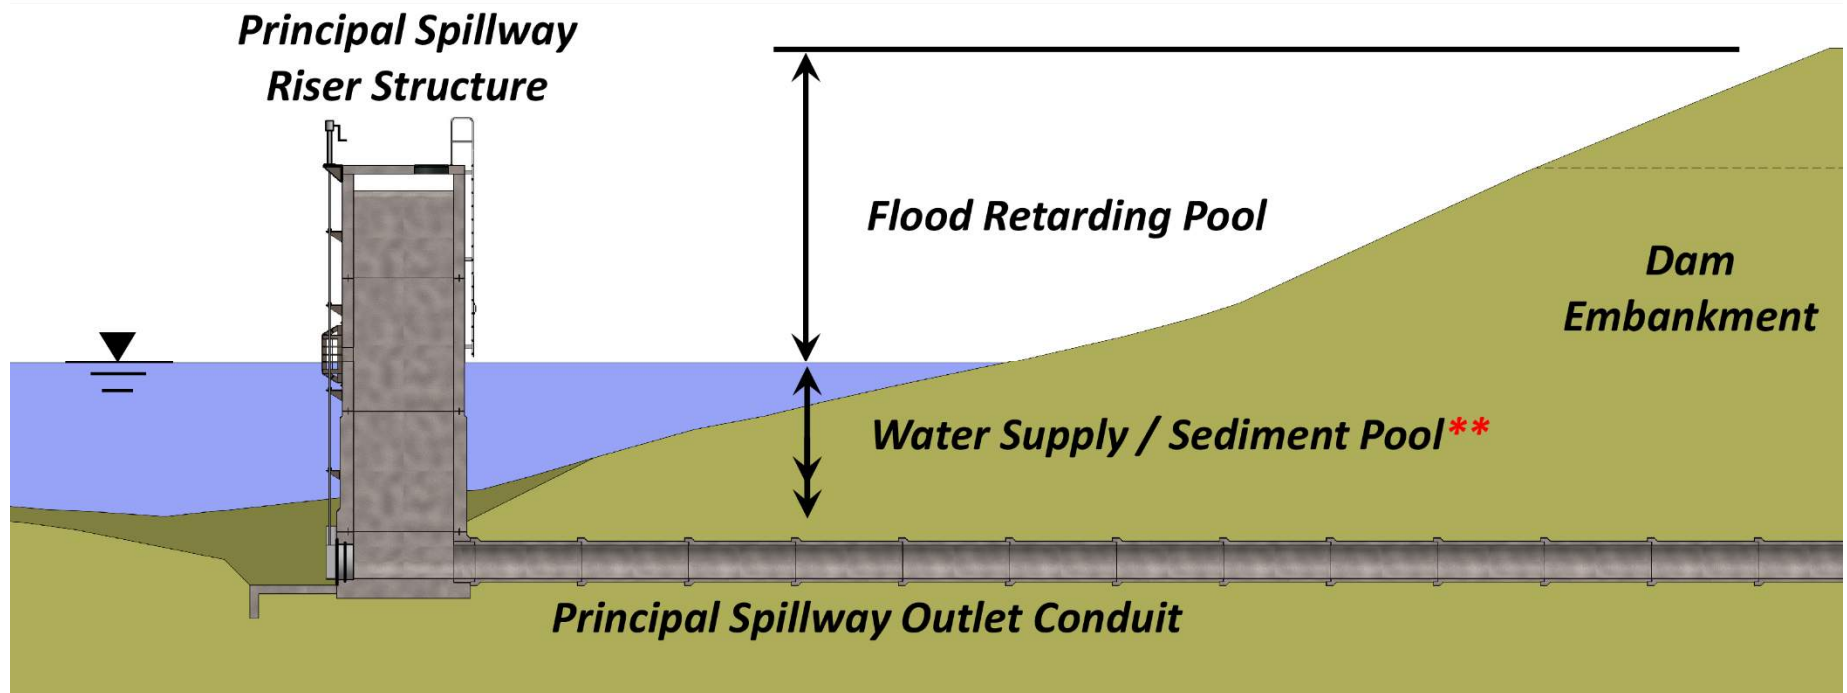
Typical Reservoir with Sediment Storage

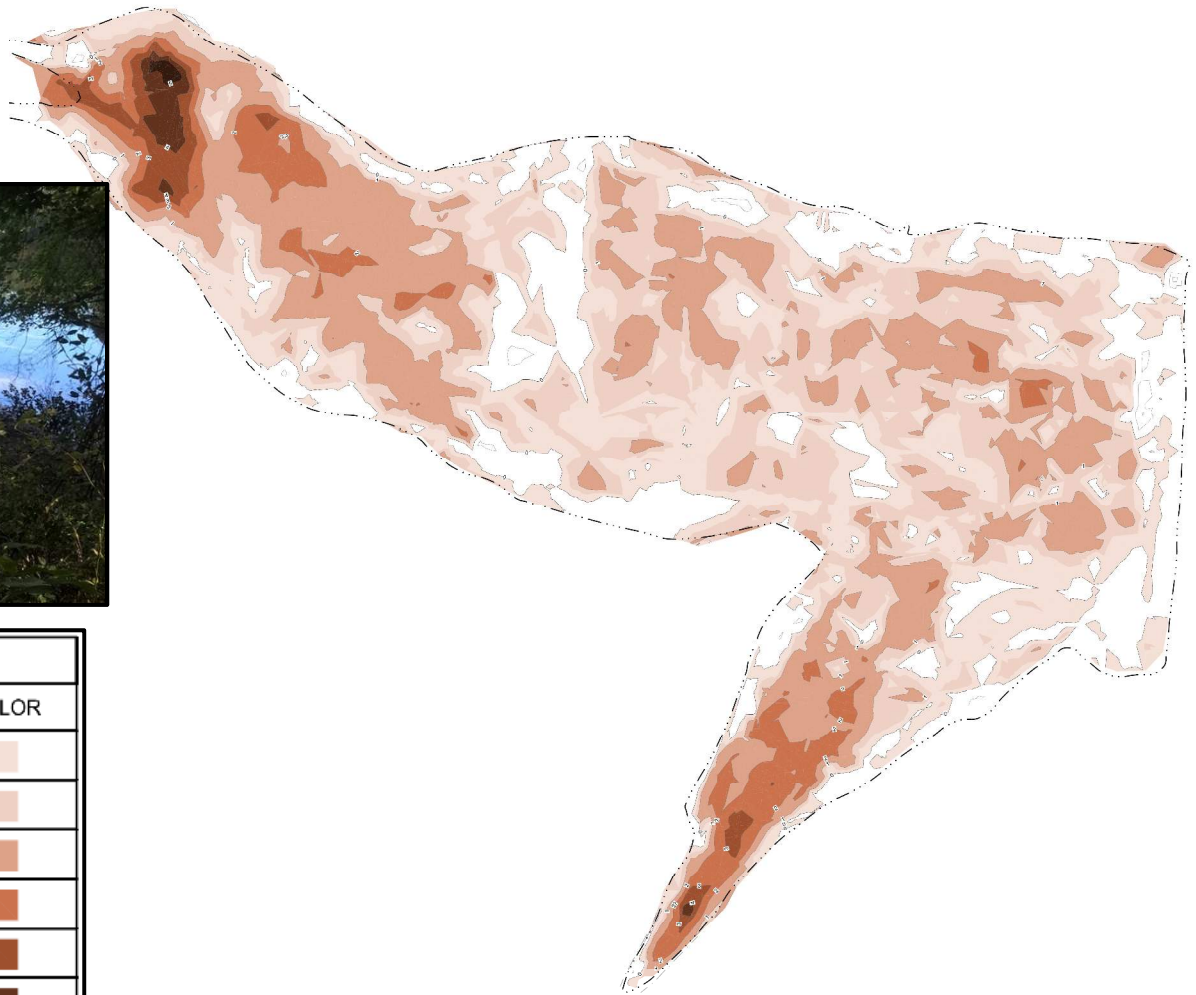
ELEVATIONS TABLE			
NUMBER	MIN ELEVATION	MAX ELEVATION	COLOR
1	0.0	0.5

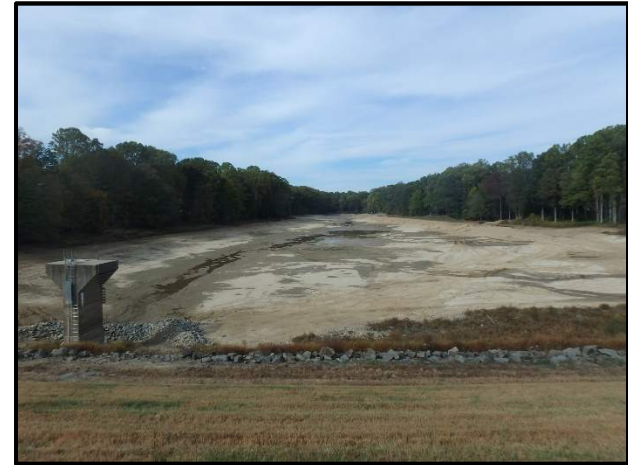
Mechanical Dredge (Dry)

- General Sequence
 - Initiate drawdown of lake
 - Establish access and staging areas
 - Establish diversion channels within lake
 - Conduct dredging
- Benefits
 - Higher daily sediment removal rates
 - Minimal sediment handling effort at disposal area
 - Potentially lower cost
 - Constructability of improvements
- Challenges
 - Very weather dependent
 - Higher potential for delays due to weather
 - Potential for odor from lake bottom being exposed
 - Need to relocate/salvage fish
